Neutral Salt Spray Test: ASTM B117-11

Sample I.D.: EVOSTone Coating System

Exova Mississauga W/O # 522265
Ref. #G552286-Issue 1
May 8, 2015

Item 001: Salt Spray Test per ASTM B117-11.

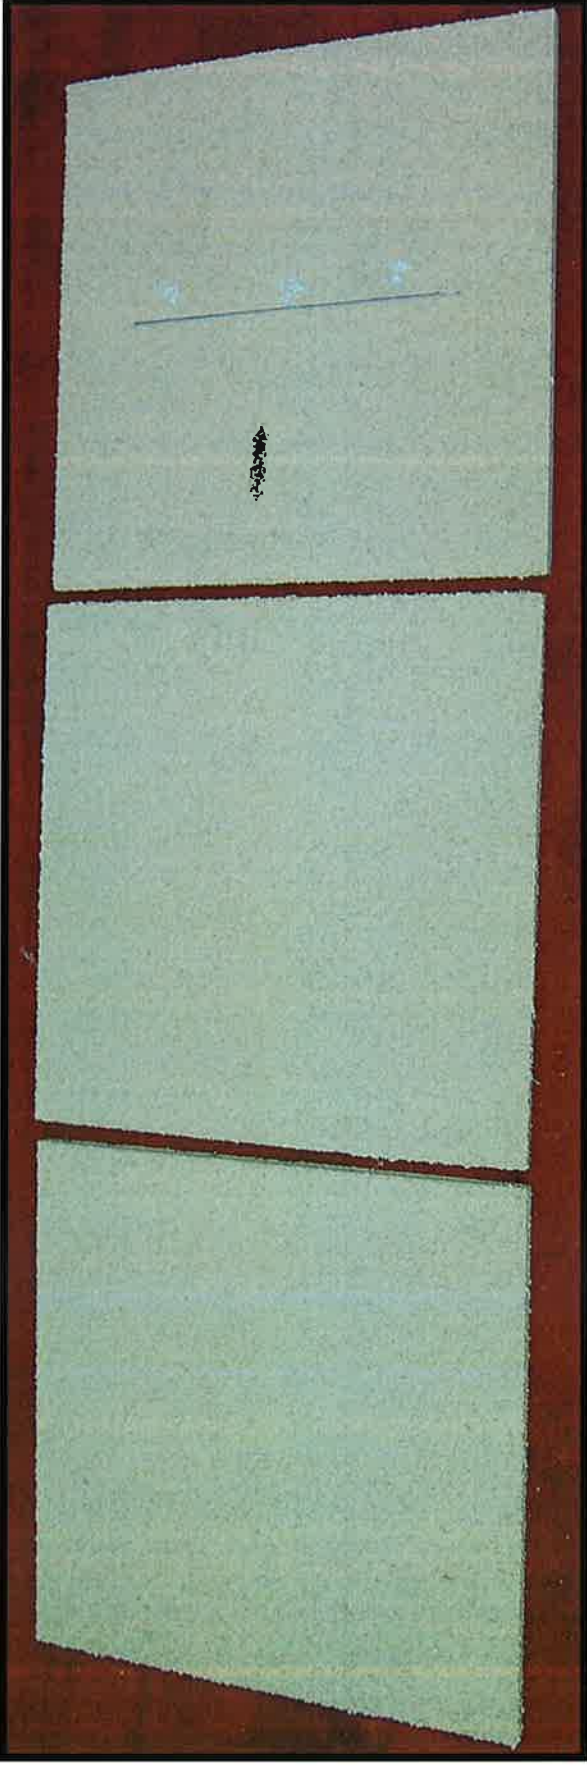
Figure 1: Photograph illustrating the specimens prior to salt spray exposure.

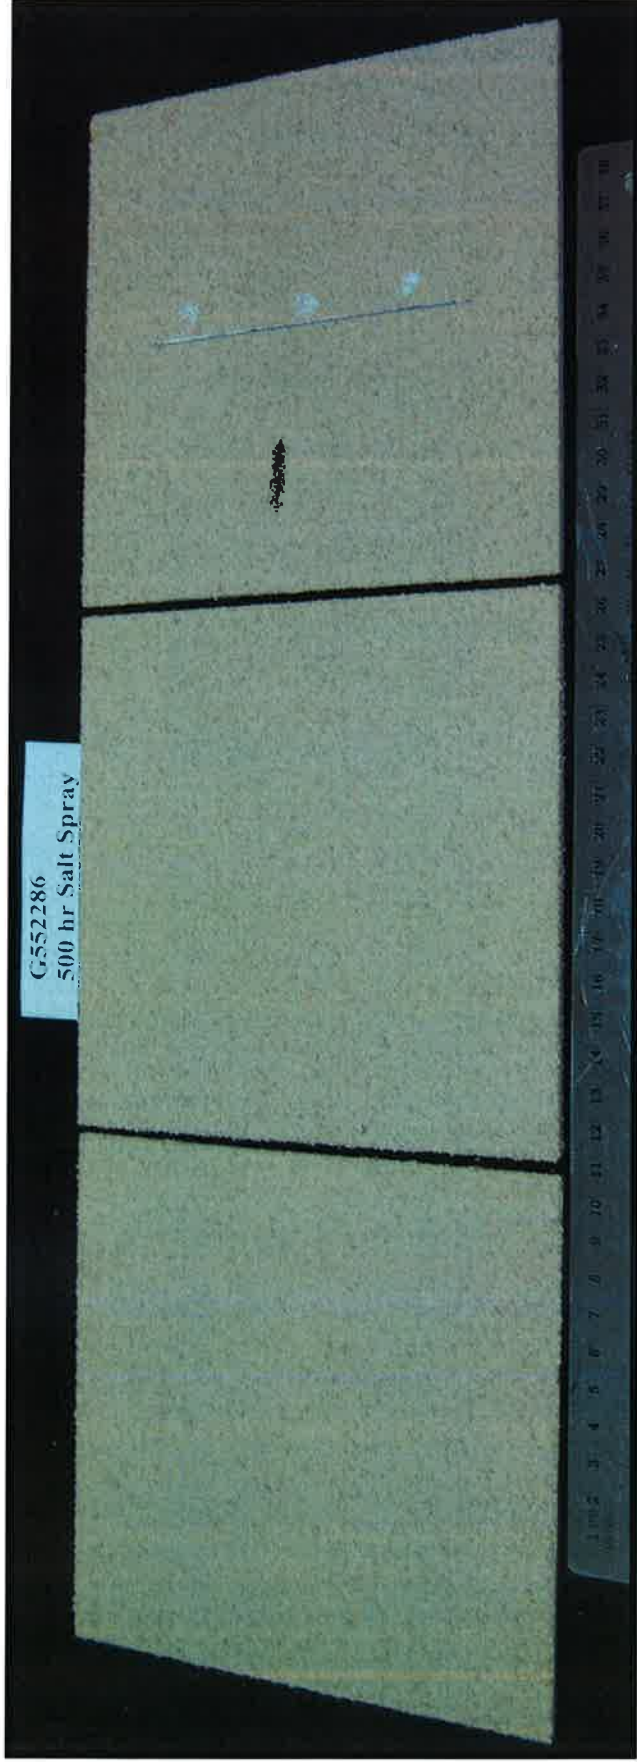
Figure 2: Photograph illustrating the specimens after 500 hours of salt spray exposure. The specimens showed slight softening with no blistering, lifting, loss of adhesion or other visible changes. There was no loss of adhesion/creepback from the scribe.

Note: Creepback evaluation was conducted per ASTM D1654-08, Method 4 (Air Blow-Off).
