EVALUATION OF “EVO Stone” COATING SYSTEM FOR IMPACT RESISTANCE IN ACCORDANCE WITH ASTM D2794

A Report to:	Carter Fabricating Inc. 326 Deerhurst Drive, Brampton, ON L6T 5H9
Attention:	Mike Libreiro
Telephone:	(905) 487-1684 ext. 103
Cell:	(905) 809-2741
Email:	MLibreiro@carterfabricating.com
Proposal No.:	15-006-349178, Revision 2
Report No.:	15-06-P0067-C, Revision 1 4 pages
Date:	June 25, 2015

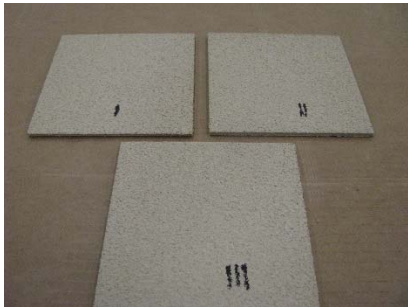
15-06-P0067

Client Sample Description	Exova Sample No.
<p>EVO STONE COATING - Stucco Coating (6" x 6" – 4 pieces & 12" x 12" – 3 pieces)</p>

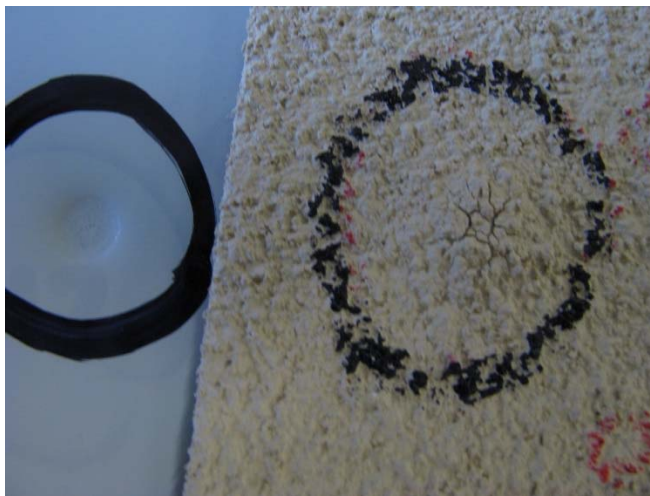
Photo 4: Typical failure when struck from back side of plate (extrusion). Image of indent on the back face is also shown for reference

Table 1 – Impact Resistance <i>Exova Sample No.: 15-06-P0067</i>			
Impact direction	Mean Impact height, mm (inch)	Impact Resistance, J (Foot-Pound)	Comments
Intrusion (Stucco coated side)	400 (16)	3.7 (2.7)	Cracking around indent radius
Extrusion (Metal Panel Side)	150 (6)	1.4 (1.0)	Impact failure centered at impact point

The average impact resistance of the front of the plate was found to be 3.7 Joules (2.7 ft*lbs). When struck from the back of the plate, the sample had an average impact resistance of 1.4 Joules (1.0 ft*lbs).

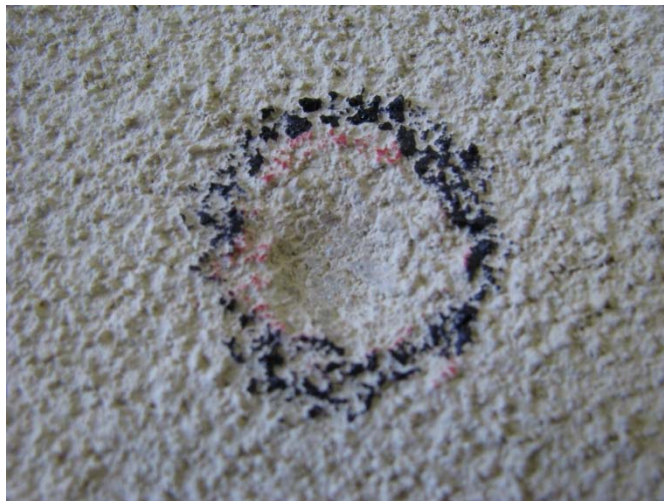
Photo 5: Typical failure when struck from front side of plate (intrusion). Hairline cracks along the outside of the indent which may not be visible in this image quality.
